Solar Eclipse and Control Room Update

Part 5

Energy Freedom Project

22 August 2017

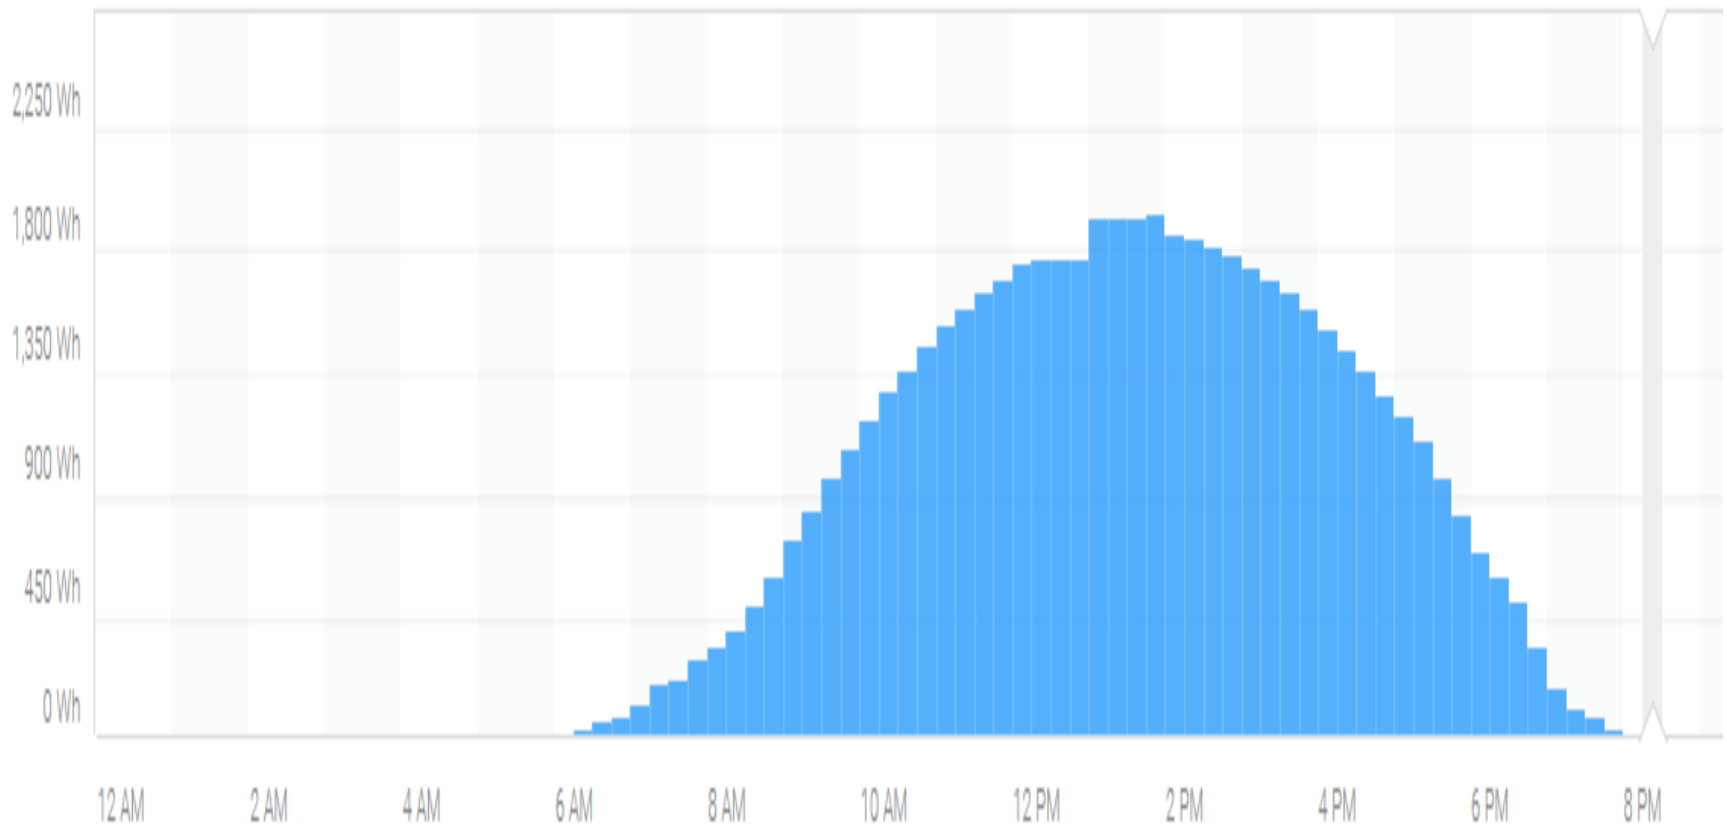
13 August 2017

Near perfect solar day

August 13, 2017 Produced
8:15 - 8:30 PM 0 Wh

- Graphs of 4 production days with different performance are next
 - A near perfect solar energy production day
 - A really terrible solar energy production day
 - A day when Hydro One failed for a couple of hours
 - Solar Eclipse of 21 August 2017 (51% blockage)
- Graphs are Watt-hours vs. time of day
 - 15 minute time lapse vertical bars
- Lifetime Production from 3 April 2017
 - 6.8 megaWatt-hours

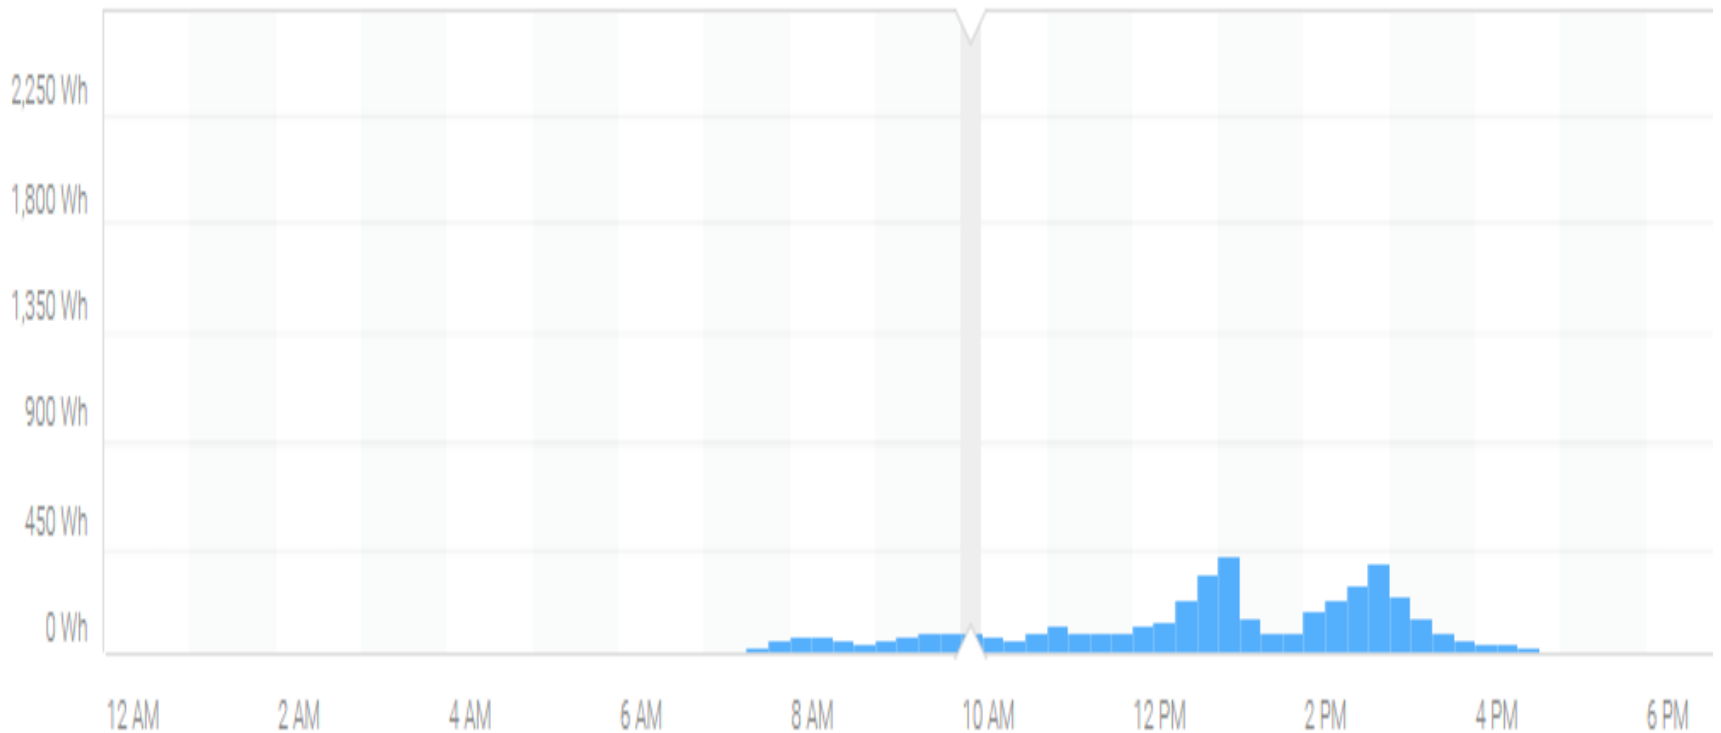
Terrible Solar Day all due to clouds

July 24, 2017 Produced
10:00 - 10:15 AM **80 Wh**

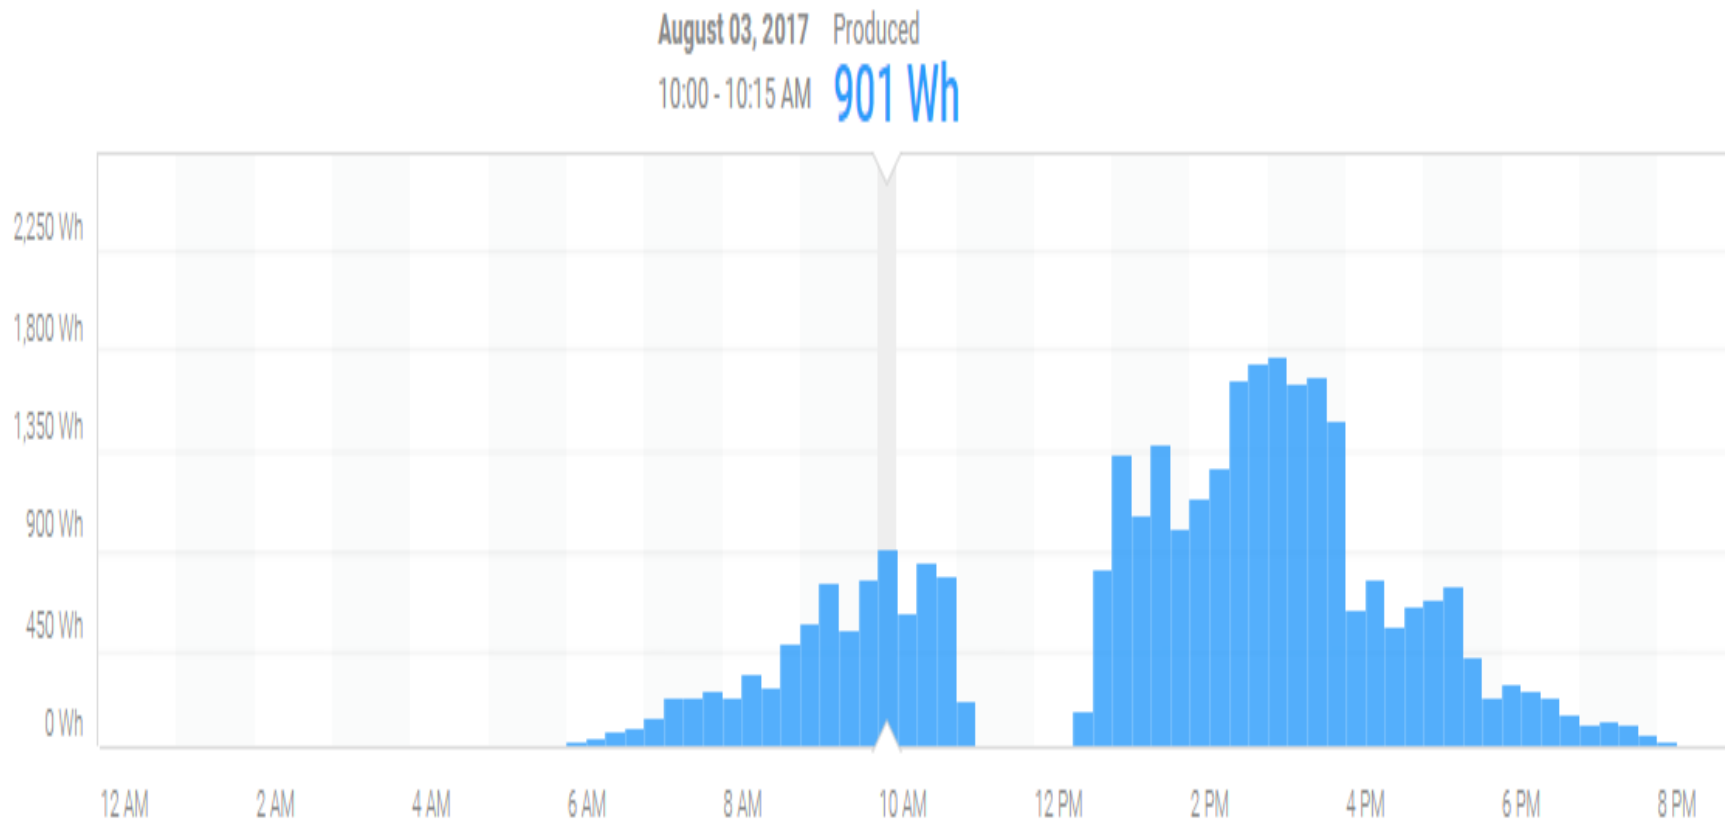
Hydro One Power disruption Solar production shutdown

Cloud variations throughout the day

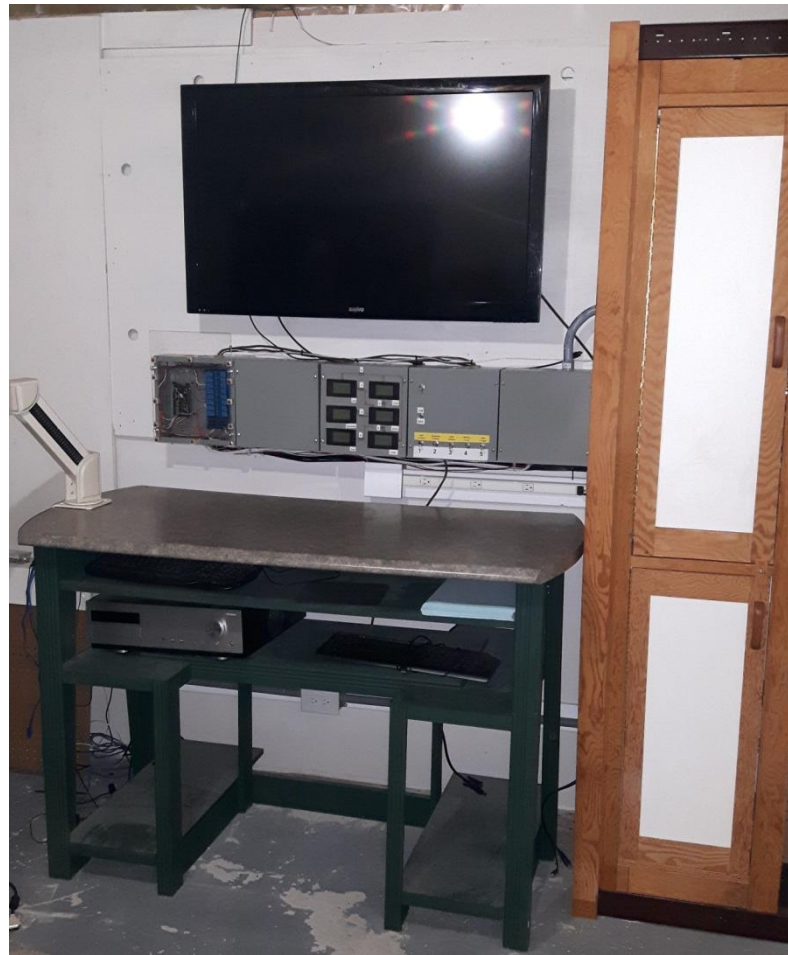
August 2017 Control Centre

- Box #1 (far left) is now a relay centre with an Arduino Mega in charge. Clear plastic permits viewing and protects wiring.
- The 7 foot rack on the right now has a pretty face. Still some trimming required.
- The cable runs on the top and bottom of the 5 boxes will be hidden soon.

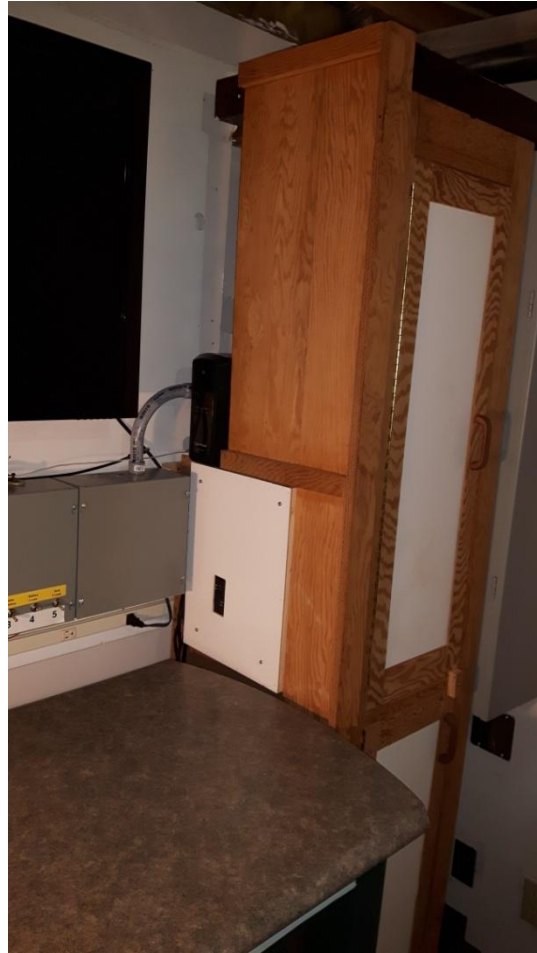
Main Rack

- Mid-picture white board hides the many cables going to the 4 channel KVM (keyboard, video, mouse) switch. Only the manual push button and some status LEDs are visible.
- Above the KVM panel is the UPS (uninterruptible power supply) for emergency power to the electronics and one 4 Watt LED emergency light.
- Still some finishing required to close this right to the back wall.

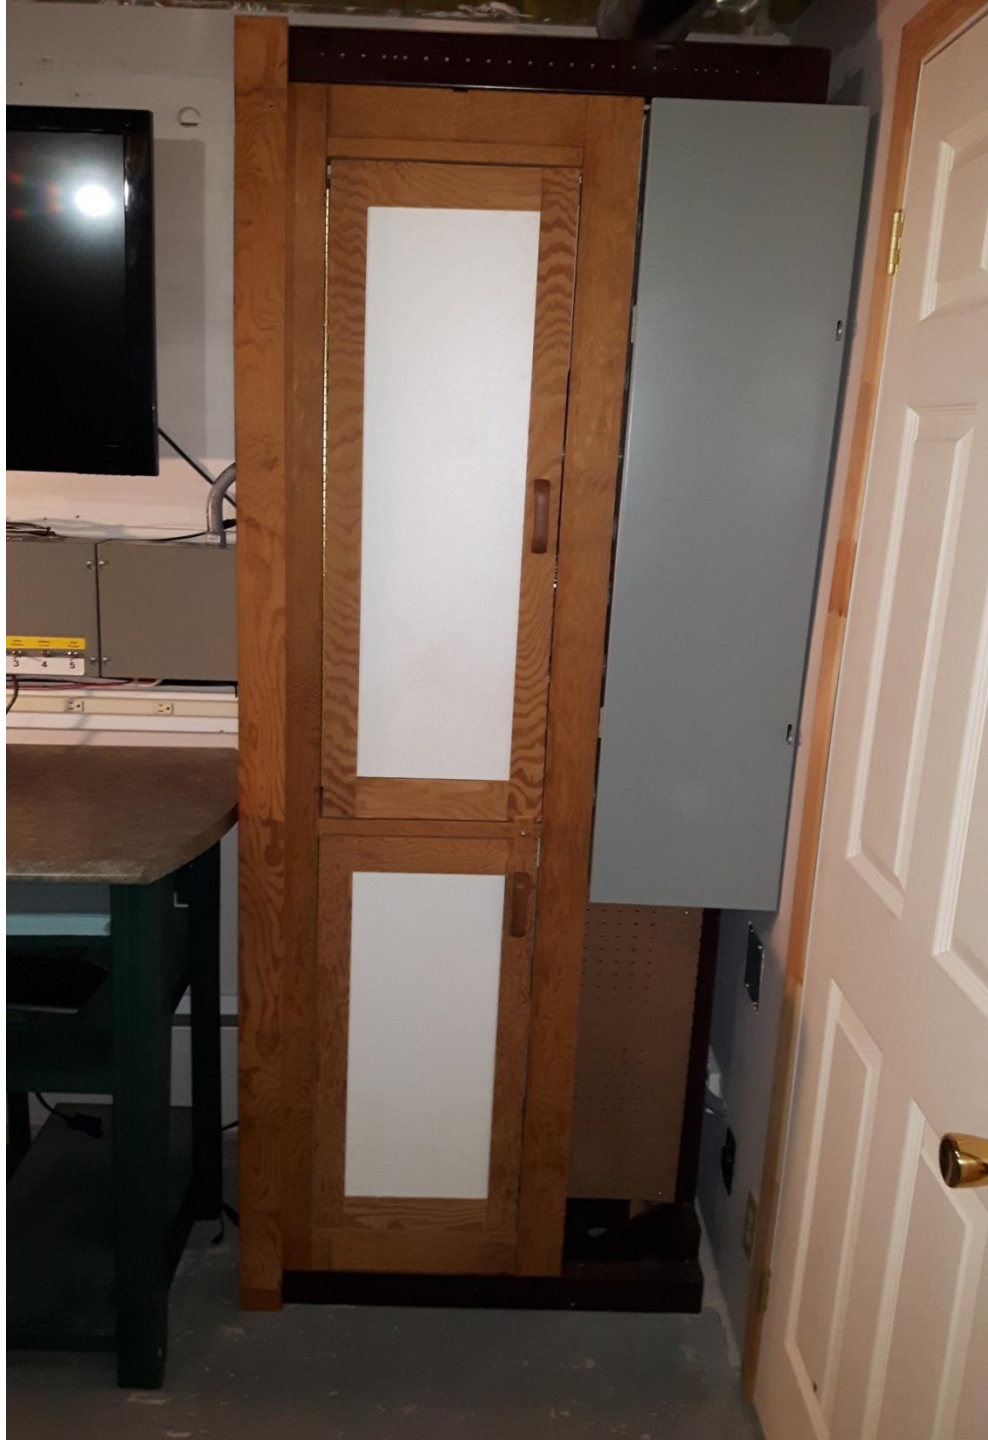
Main Electronics Tower

- The grey box is the main contactor box shown previously in an update.
- Two whiteboard doors protect the upper chamber and the lower chamber of electrical equipment like power supplies and Raspberry Pi computers.
- Some finishing is still required to close out the lower right and add trim to equipment rack.
